September 24, 1973

REPORT ON SKYLAB-M551 SAMPLES  
CONTRACT NO. NAS-8-28725

SPECIMEN PROCESSING

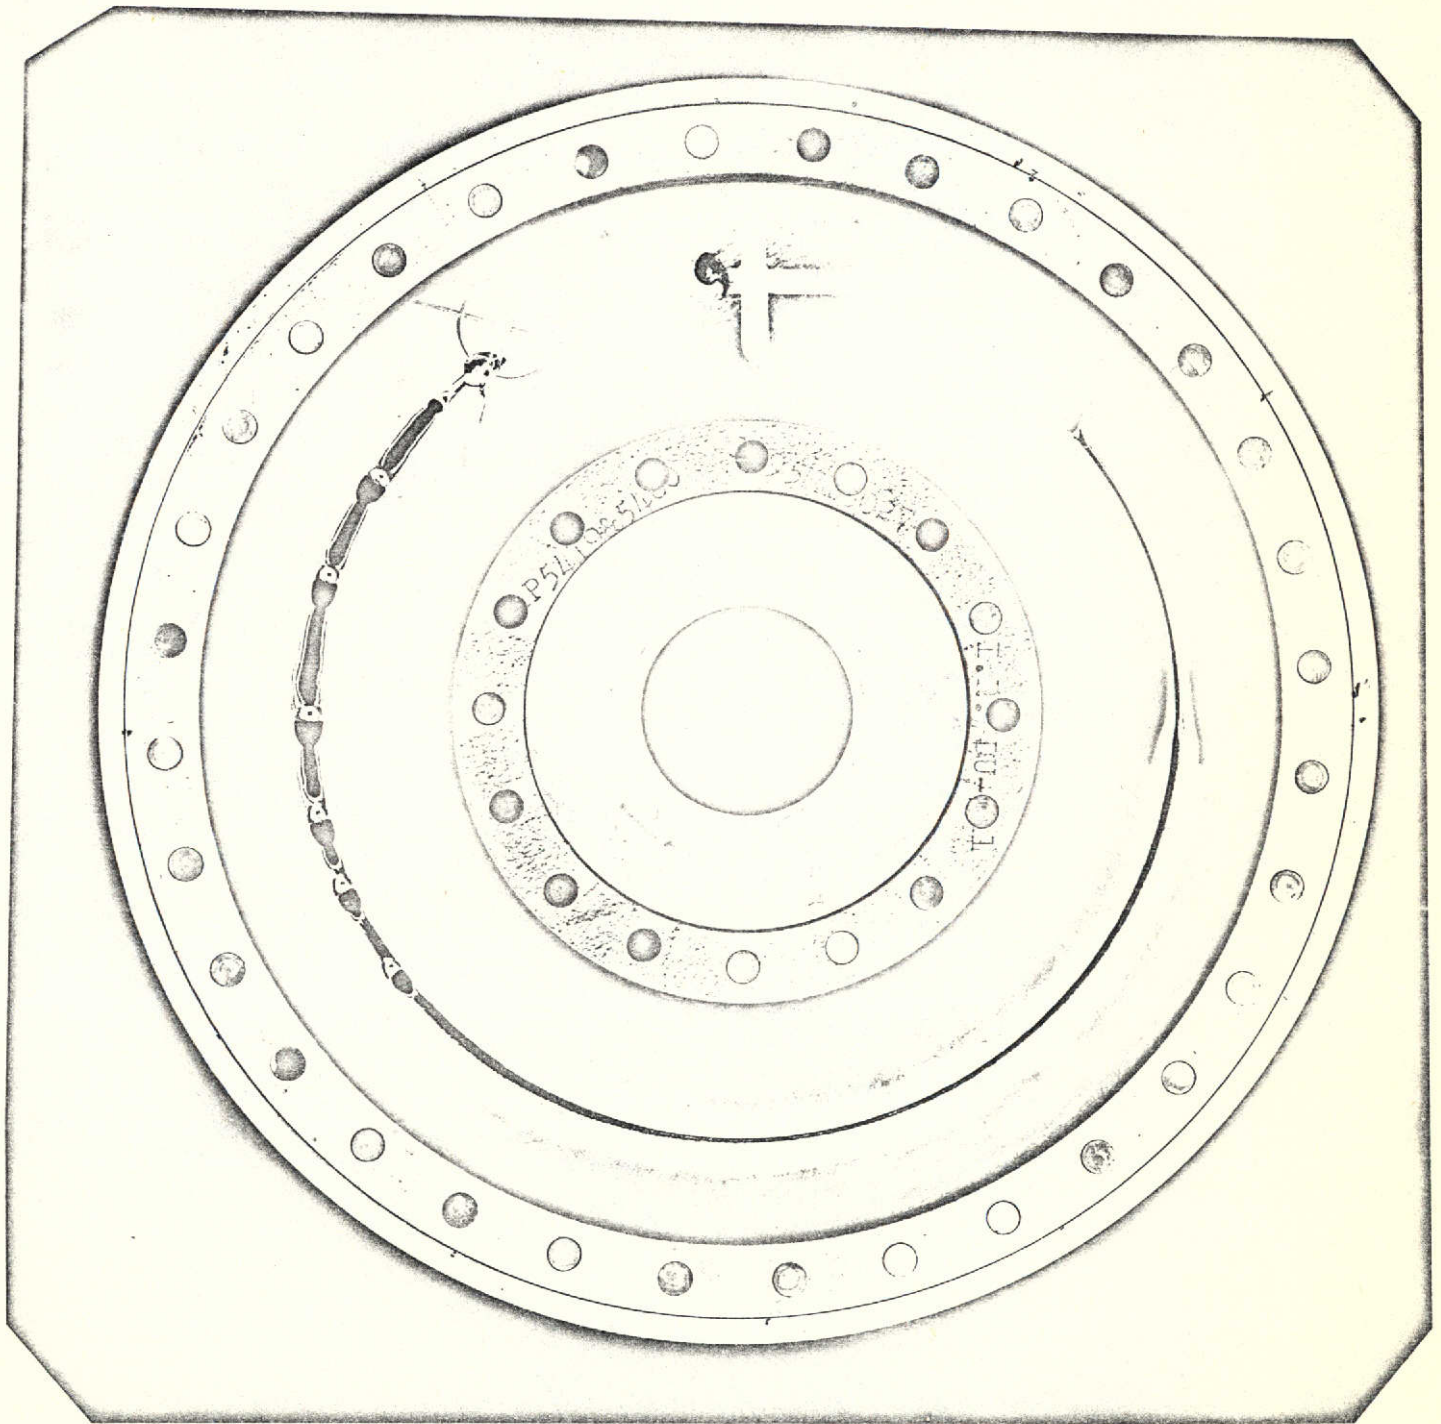
FIGURE IV-11. FRONT SURFACE S/N 145

At 0 degrees the target has been used to locate the beam with a melted region almost exactly on center. Flow back of molten stainless steel has occurred all the way from the edge of the target back to the center. A solid weld region extends from the target to the point where the thickness decreases and the cutting commences. The cut width is 1mm. In the cut region the surplus molten metal has accumulated in essentially circular balls. In this specimen, all the balls lie along the inside edge of the cut region. There are 13 of the ball accumulations along this edge. The last of the ball accumulations is slightly beyond 60 degrees, although the actual welding does not start until about 75 degrees. As soon as the weld initiates the surface ripples which are very elongated are immediately apparent. Undercut along the inside edge is also immediately apparent. Starting at about 130 degrees the undercut is not as severe and, in fact, may not exist although there is an occasional indication of undercut still along the inside edge. At about 160 degrees, there is a perturbation in the surface appearance related to a mass change as the disc rotates. At the change in thickness going from the thin to the thickest material, there is a change in the bead appearance with the top surface appearing to be more elevated in the partial penetration region. The weld terminated slightly short of the termination hole with a shallow elongated crater. There are occasional instances where small spatter particles can be seen adhering to the inside edge adjacent to the weld. Surface appearance of the weld is typical for stainless steel electron-beam joint.

There is no evidence of any cracking or weld defects other than the undercut. The weld width initially is 1-1/2mm., widening to 2.5mm. (full penetration) and then to 3 mm. (partial penetration).

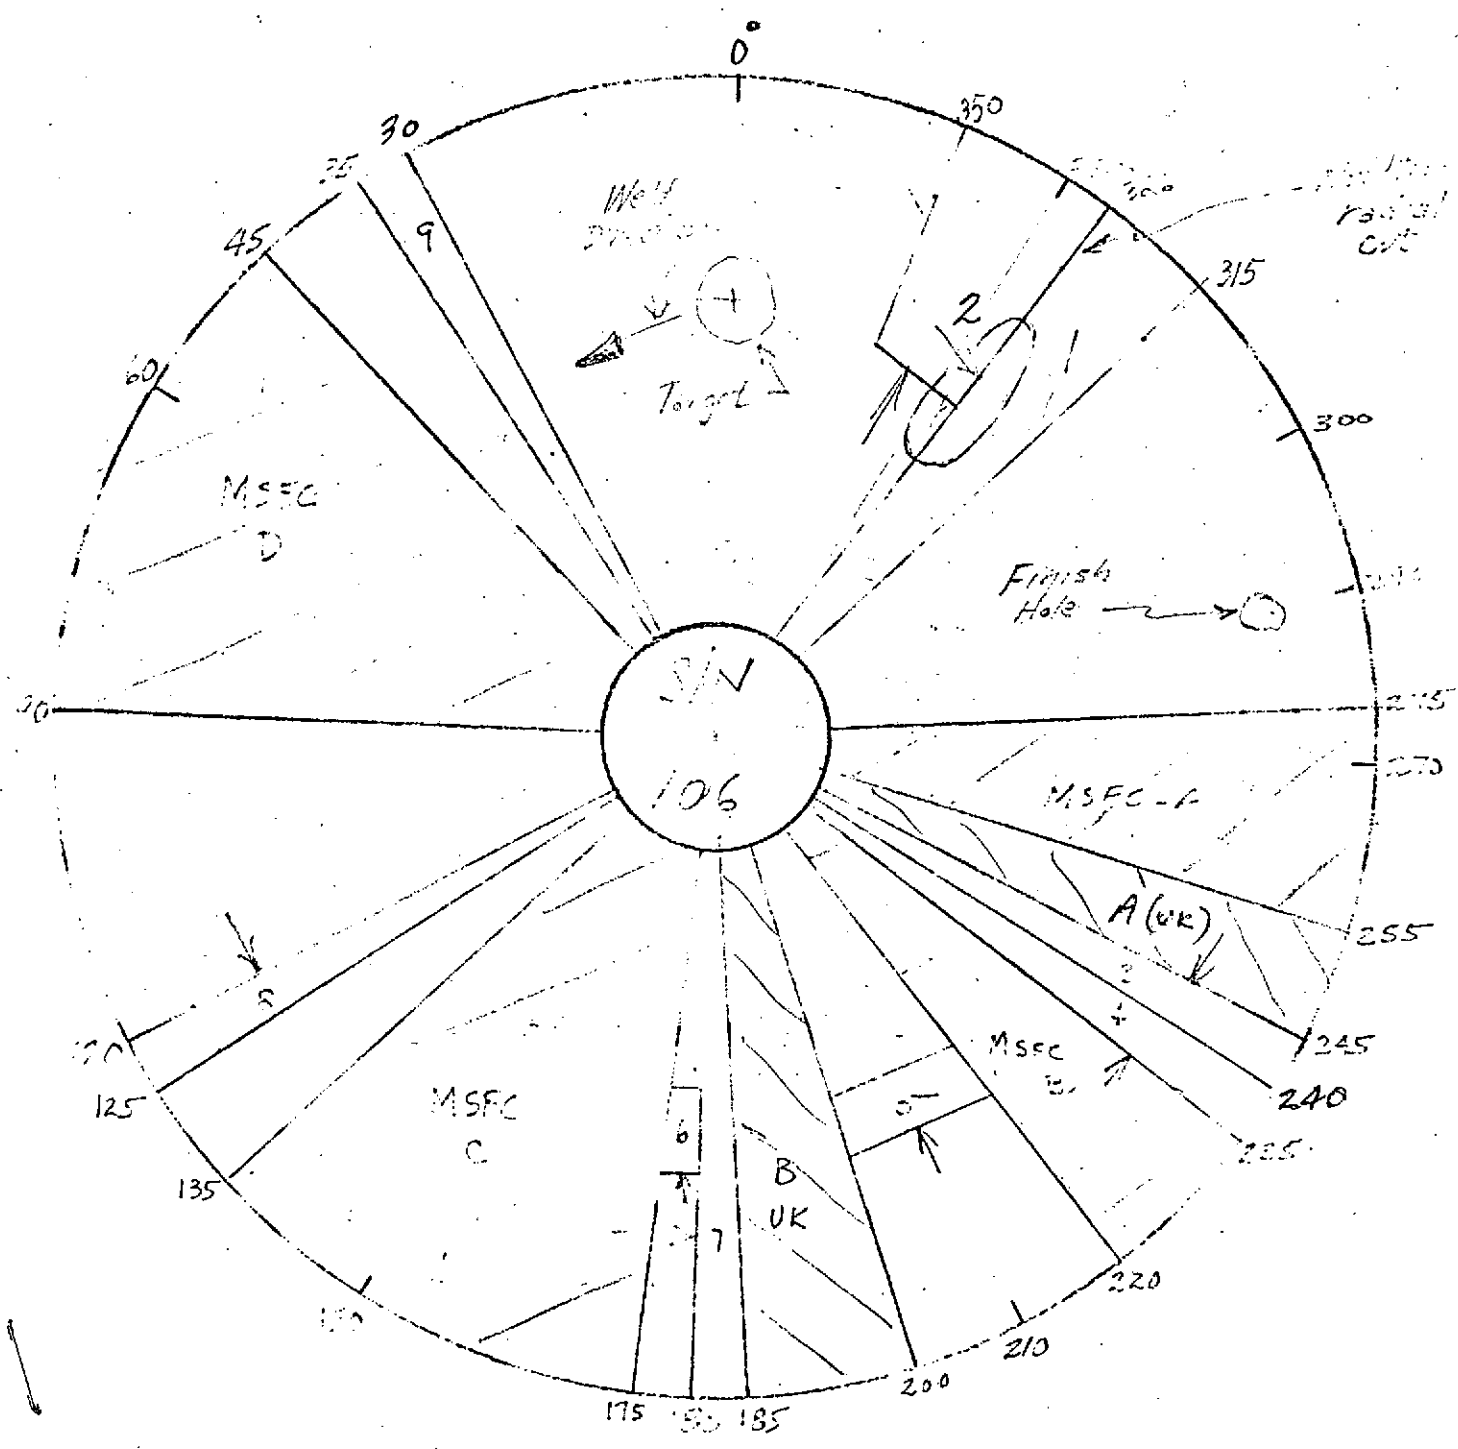
FIGURE IV-10. SECTIONING PLAN S/N 106

Both stainless steel discs have been sectioned as shown in Figure IV-10. All sections have been mounted and examined. Results of these examinations will be reported in the future.
